Callingwood Court Condominium

2015 Reserve Fund Study

Edmonton, Alberta

August 2015
RJC No.: EDM.100641.0003

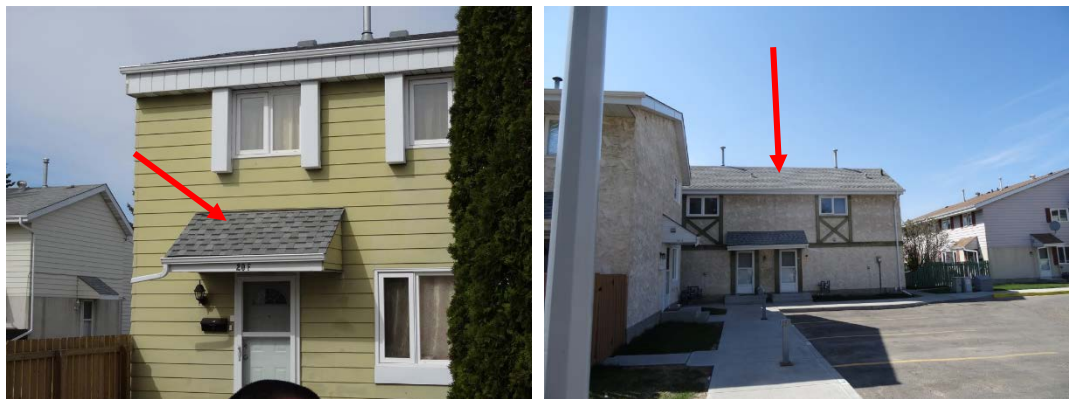
- We were informed that the original roof shingles were replaced with laminate shingles between 2009 and 2015. The re-roofed buildings include Building Blocks 2, 5, 8, 11, 15, 17, and 20 (Photos 13 to 15). Specific details regarding the re-roofing work were not available during preparation of the draft.

Photos 13 and 14: Asphalt laminate shingles applied to Building Blocks 20 and 15

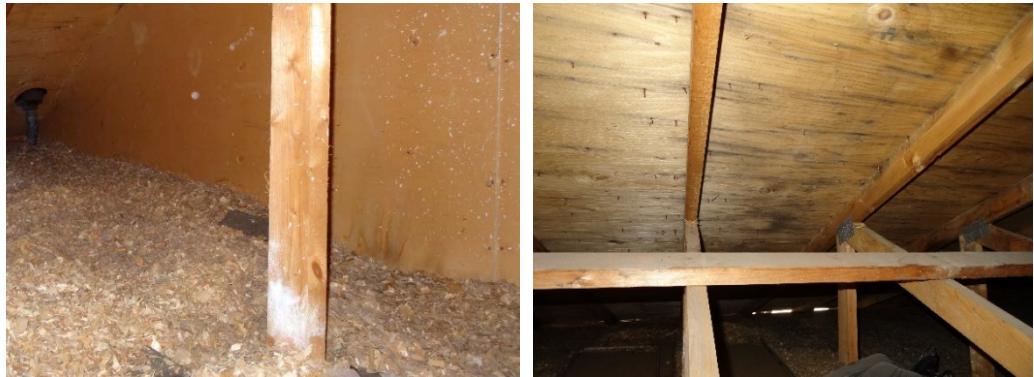
- It should be noted that adding insulation would not prevent air leakage from the unit into the attic space. If warm moist air leakage occurs in the attic space condensation is anticipated to develop in the colder months. Further review would be required to assess the extent of air leakage occurring at this time.
- Moisture stains on the various framing members and sheathing were evident in the attic spaces (Photos 20 and 21). Moisture stains may be the result of condensation or possibly water leakage through the roof. Further review would be required to determine if there are roof leaks or condensation developing at these units.

Photos 20 and 21: Moisture stains on gypsum board and framing members

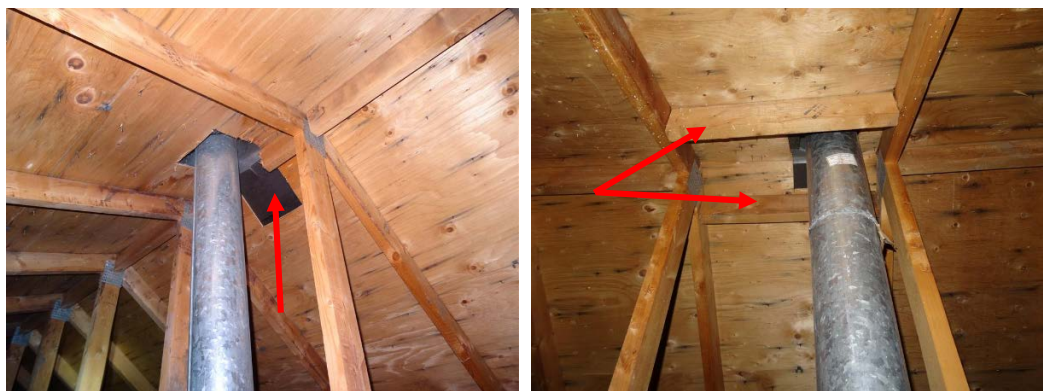
- A variety of mechanical ducts penetrate through the attic regions. In some units, the original roof framing members have been removed or modified where the ducts extend through the roof deck sheathing (Photos 22 and 23). Further review is recommended to assess the extent of damaged members. Repairs are recommended where framing members have been cut.

Photos 22 and 23: Roof framing cut or modified at Units 4A and 5D

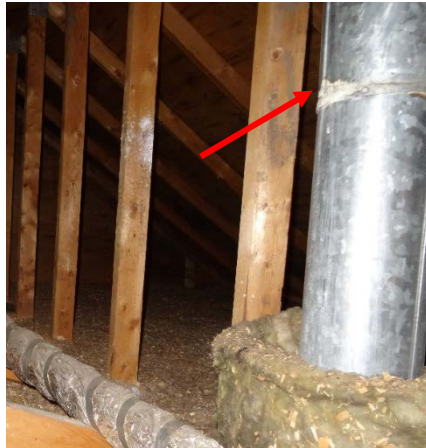
- Corrosion was observed at the seams of a number of the flues (Photo 24). Details regarding the frequency in which these flues are inspected is not known; however, further review is recommended at this time to assess the condition of all flues.
- Ductwork has become detached from the exhaust vent and is directing warm moist air into the attic space. This condition has resulted in a buildup of humidified air within the affected attic spaces and stains to the wood-framing members. Stain marked wood shaving opposite a bathroom exhaust vent were also observed during our initial site review (Photos 25 to 29).

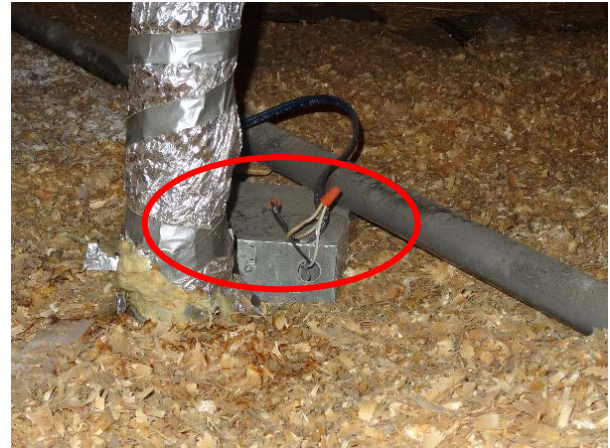
Photo 24: Corrosion at flue seam Photo 25: Unsecure electrical box and exposed wires

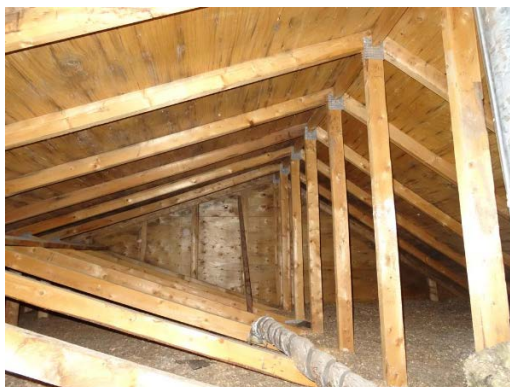
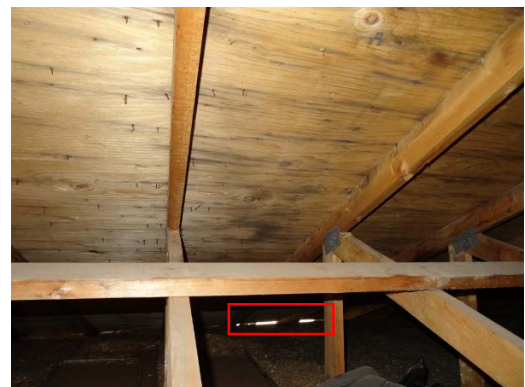
Photos 28 and 29: Moisture stained roof deck and daylight viewed at roof edge

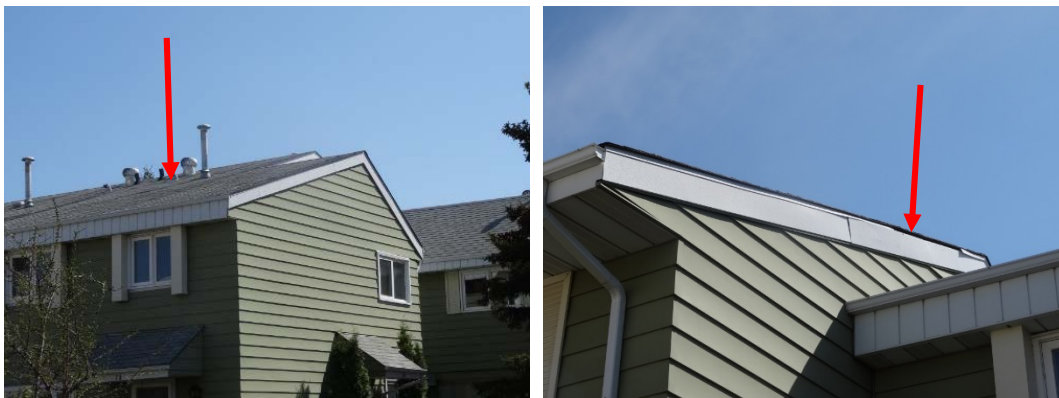
- The shingles above Building Block 1 have begun to exhibit curling conditions and a piece of rake flashing was missing at an upper roof level (Photos 30 and 31). Repairs are suggested to prevent moisture for migrating into the exposed roof edge.

Photos 30 and 31: Curling of shingles and missing rake edge flashing above Unit 1F

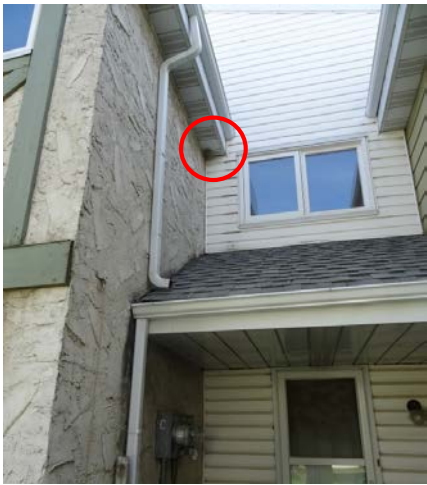
- The soffits and fascia are generally in good condition. We do note that some soffit panels were discoloured at the intermediate roof overhangs (Photo 34).

Photo 34: Stain marked soffit panels at intermediate roof level

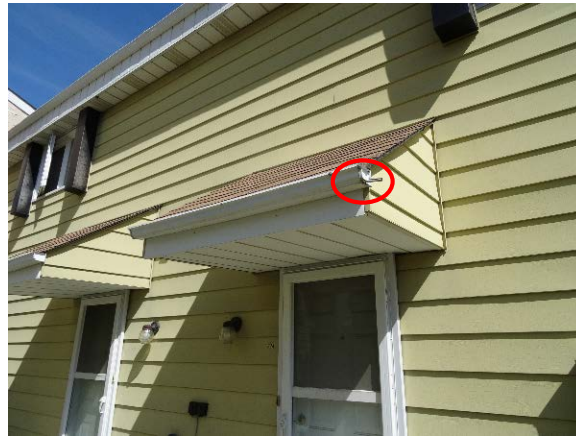
- The majority of the shed roofs above the unit entries are not provided with downspouts. Past attempts to drain the gutter sections include use of a metal grommet sleeve (Photo 40).

Photo 40: Grommet sleeve used to drain entry roof

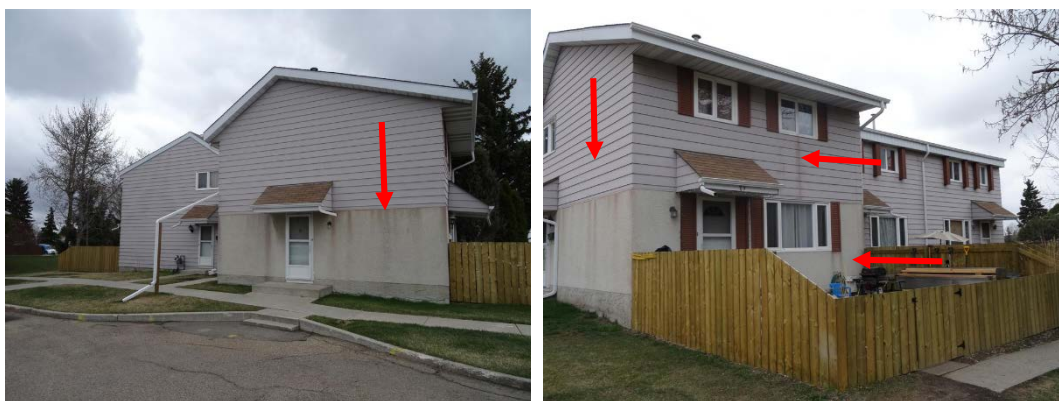
- Stain marking of the stucco and metal siding was observed at various wall locations including the main, 2nd floor, and below selected suite windows. Delamination of the stucco coating was also observed where a downspout extension penetrates the south exposure of Unit 9A (Photos 45 to 50).

Photos 45 and 46: Stain marking of stucco finish surfaces at Building Block 7

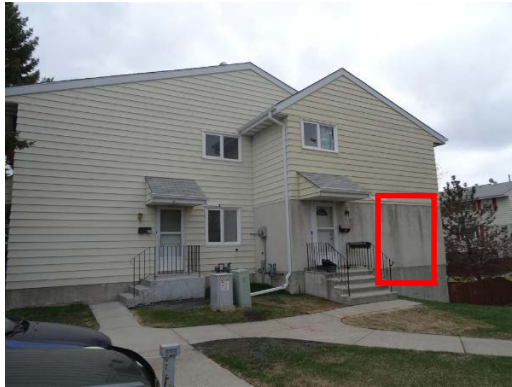
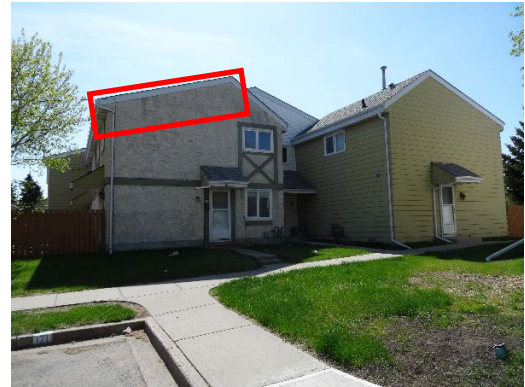
Photos 47 and 48: Stain marking of stucco at Building Blocks 6 and 21

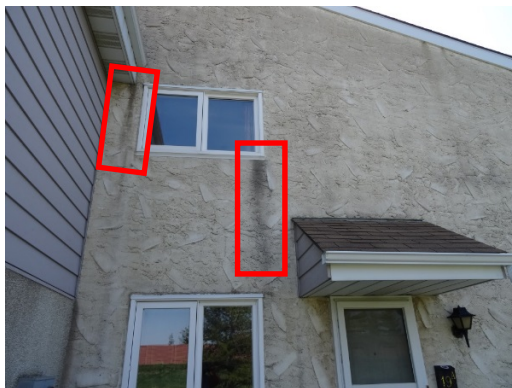
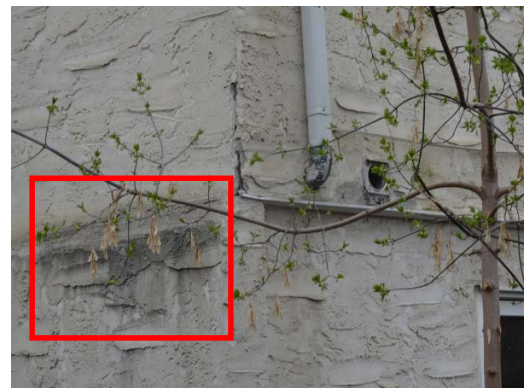
Photos 49 and 50: Stain marking below window and delamination near downspout at 9A

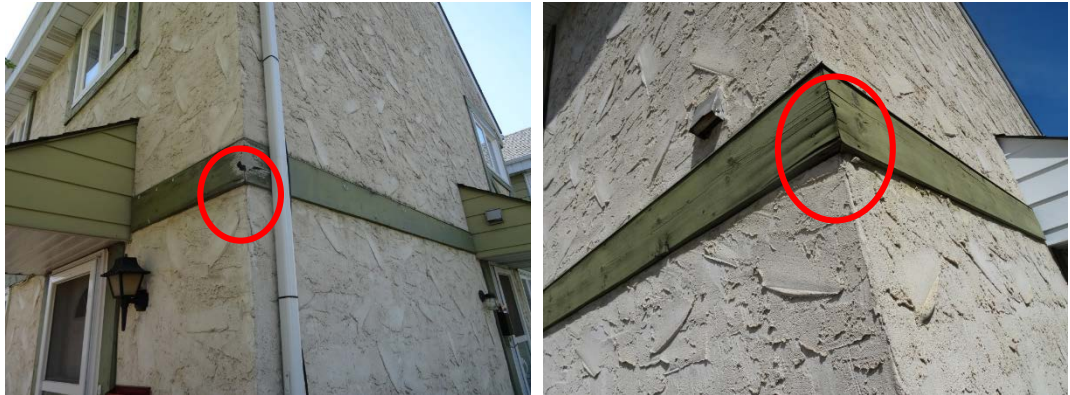
- The wood trim boards have are in fair condition, with evidence of wood rot conditions viewed at several wall regions (Photos 54 and 55).

Photos 54 and 55: Deterioration of wood trim boards at various wall regions

- Selected trim board repairs are anticipated under operating budgets until replacement is considered. Budgets related to eventual replacement of the wood trim boards are included in A2.06.
- The storage garage located on the west side of the complex was being demolished during a site visit (Photo 56). Specific details regarding the work were not available during our review. We were informed that the structure will not be rebuilt and that no budgets are to be included for replacement of the garage at this time.

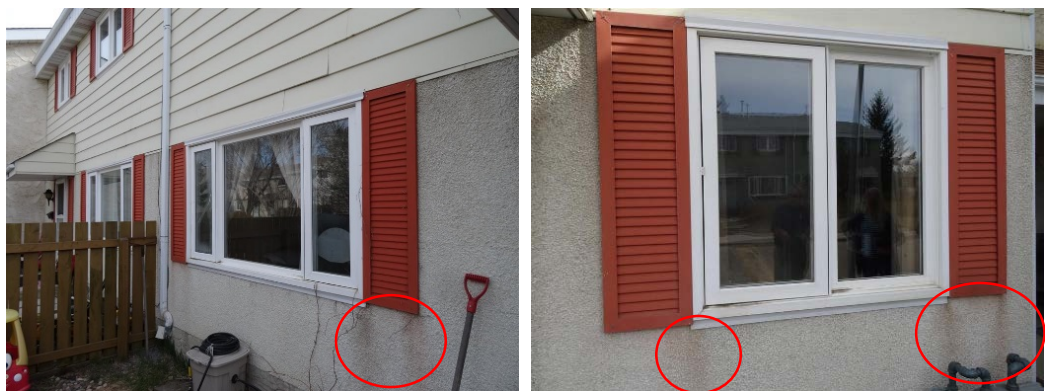
- Commentary provided by some of the Unit Owners indicated that coolness is typically felt on the perimeter of the windows during winter months. Further review to help determine any possible shortcoming with the air sealing of the affected suite windows is suggested.
- We note a number of items that will require future review and maintenance repairs to the suite windows including the operable units, interior gypsum board, and locking hardware (Photos 63 to 66).

Photos 63 and 64: Stains at operable casement units on west and south sides of Unit 21C

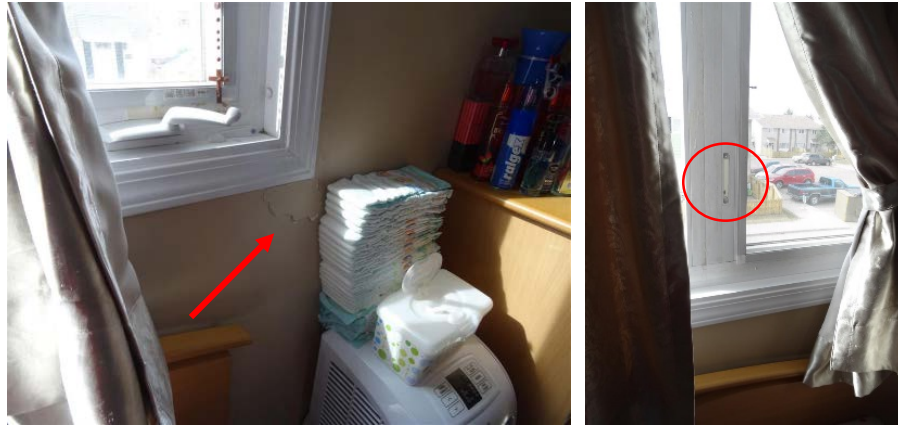
Photos 65 and 66: Gypsum board and missing locking latch at 2nd floor window (Unit 21C)

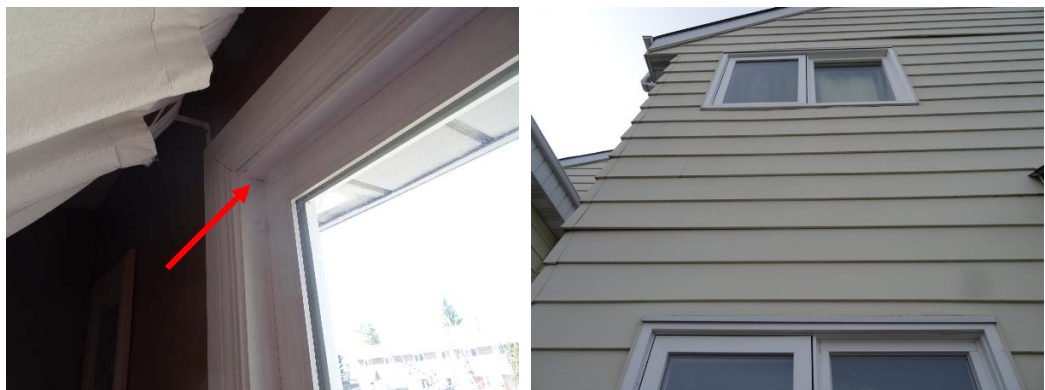
- Past instances of moisture-intrusion at select 2nd floor windows were also reported during our interior review. We observed stain marking of the interior frames and partially detached metal siding at these locations (Photos 67 and 68).

Photos 67 and 68: Stain at 2nd floor window (Unit 4A) and loose siding (Unit 14C)

- The suite window at Unit 4A is protected by the upper roof overhang. The gap in the metal siding may allow rainwater to penetrate to the backup wall. Future review and selected removal-of the interior and exterior wall finishes to help determine the source of moisture ingress is suggested at both suites.
- Select windows include metal flashing inserted above and below the window units. This type of installation is likely attributed the method used by a particular window contractor retained in that given year of the program. We note the head flashings have been caulked at various suite windows (Photos 69 and 70).

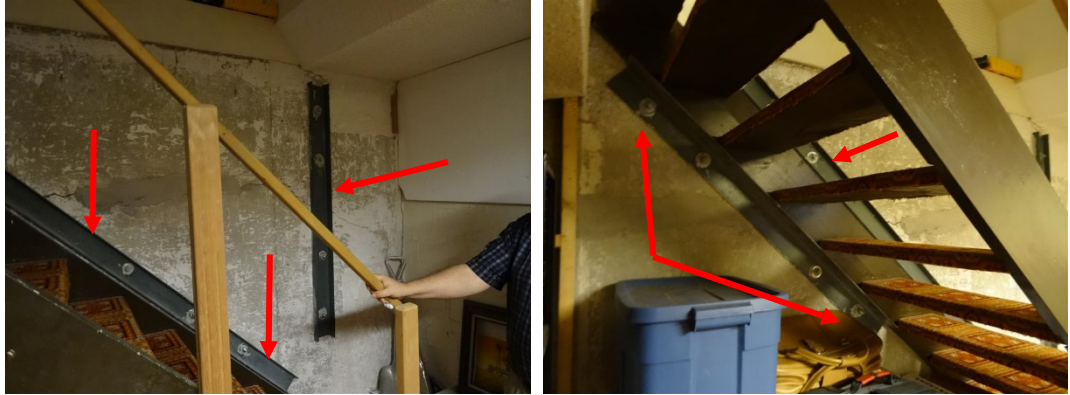
- We understand horizontal cracks have developed in the foundation walls of select units. The full extent and locations of cracking are not known. We did view past repair attempts at one basement location. The attempts at this location included securing of a steel framing member over cracks in a foundation wall near the basement stairs (Photos 74 and 75). We understand a structural engineer was not involved with the repairs at this unit.

Photos 74 and 75: Steel framing members secured to basement foundation wall

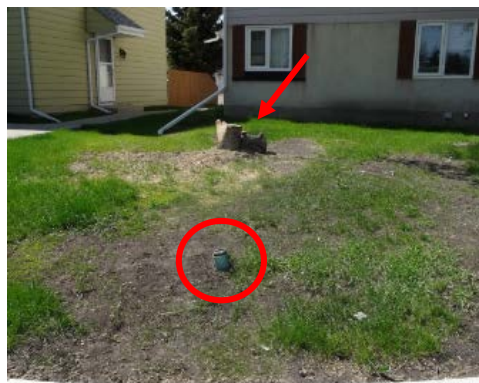
Photo 78: Tree stump and exposed shut-off valve

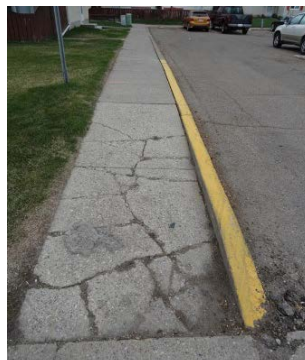
- Surface cracking of the common area sidewalks was observed (Photo 81). Further review of these slabs may be required where differences in elevation pose a tripping hazard.

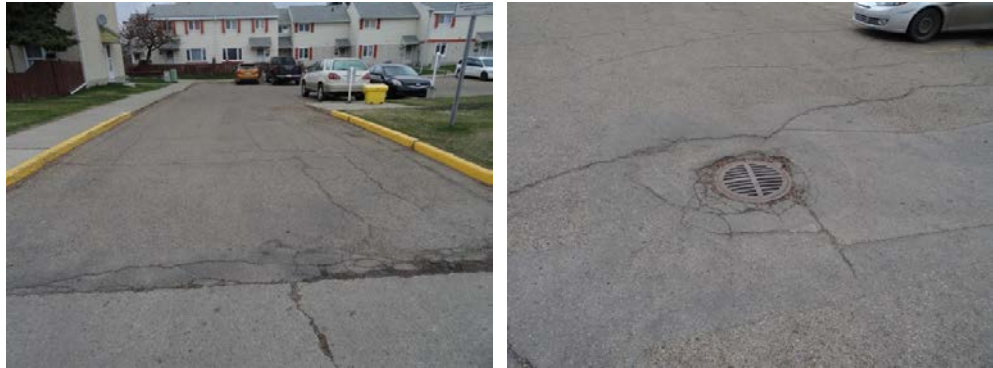
- The majority of the asphalt pavement is in fair to poor condition, with cracking patterns and general degradation of the paved surface at various locations (Photos 91 to 94).

Photos 91 and 92: Pavement condition at south and southwest parking lot catch basin

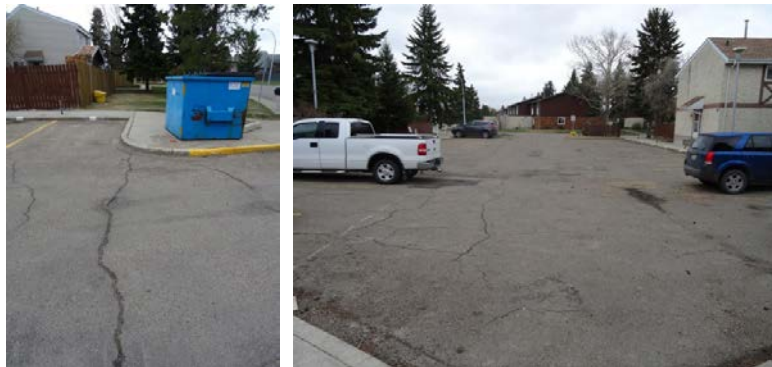
Photos 93 and 94: Transverse crack and deteriorated pavement at northwest parking lot

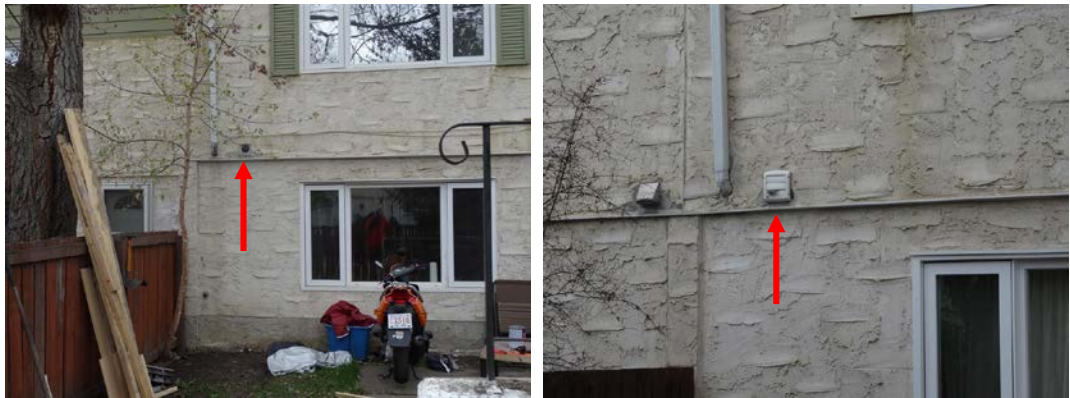
Photos 104 and 105: Missing cover and buildup of lint at dryer exhaust vents at Block 6

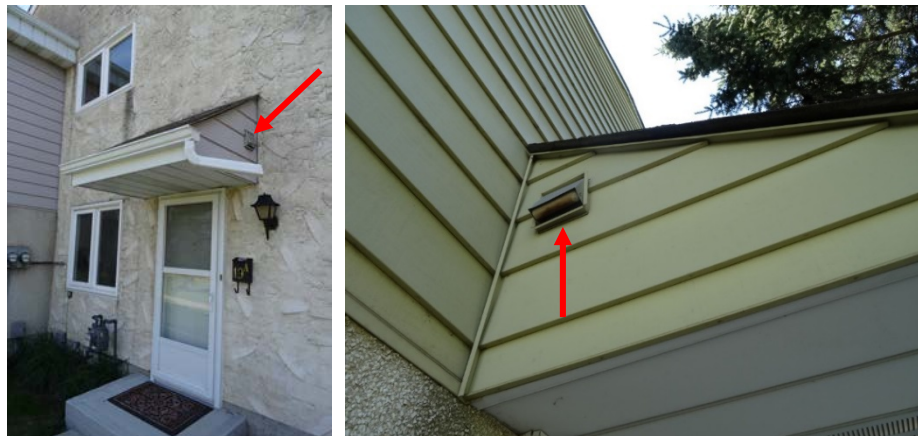
Photos 106 and 107: Blocked exhaust vents at unit entry canopies
