Callingwood Court Condominium

2015 Reserve Fund Study

Edmonton, Alberta

August 2015
RJC No.: EDM.100641.0003

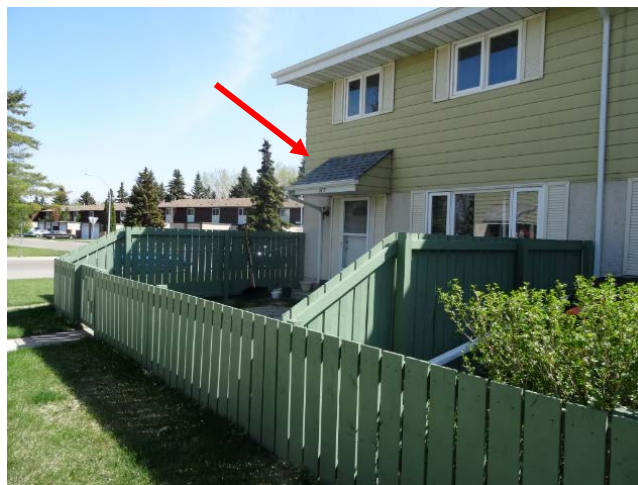
- We were informed that the original roof shingles were replaced with laminate shingles between 2009 and 2015. The re-roofed buildings include Building Blocks 2, 5, 8, 11, 15, 17, and 20 (Photos 13 to 15). Specific details regarding the re-roofing work were not available during preparation of the draft.

Photo 15: Asphalt laminate shingles applied to Building Block 11

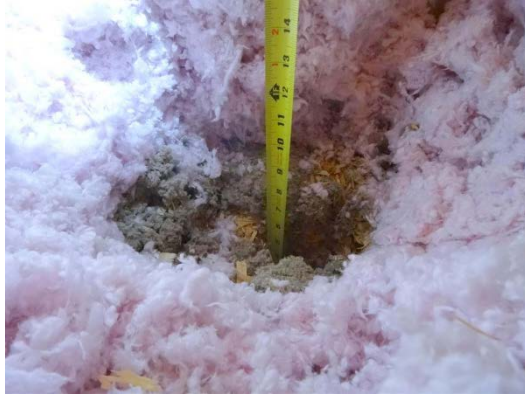
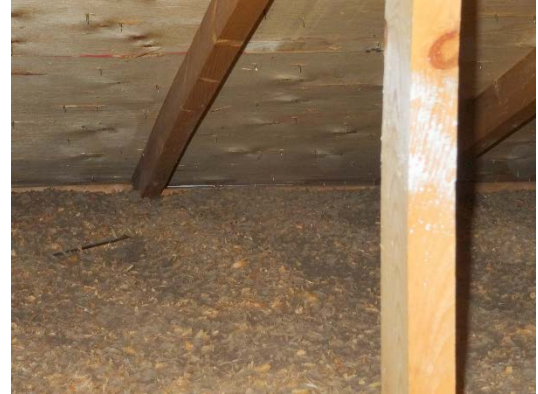
- A review of the selected attic spaces was performed during our site visits. We understand the insulation level within the attic space of most units has been increased. The thermal insulation consists of a combination of blown-in cellulose or fibreglass batt insulation, and the originally installed wood shavings (Photos 16 to 19).

Photos 16 and 17: A combination of blown in insulation and wood shaving in attic spaces

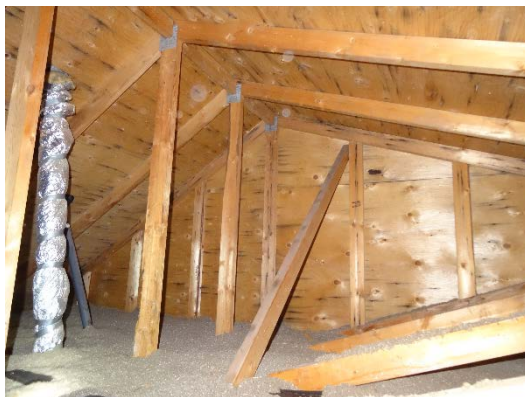
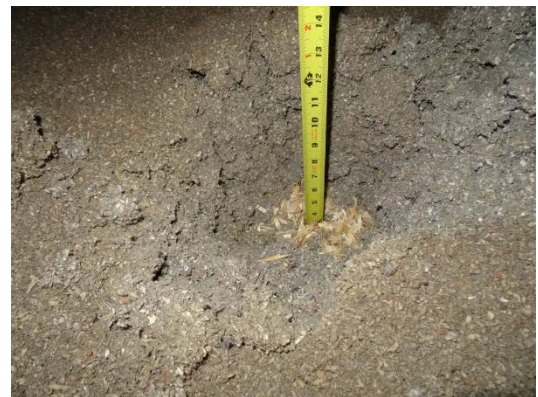
Photos 18 and 19: Blown-in cellulose over wood shavings within attic space

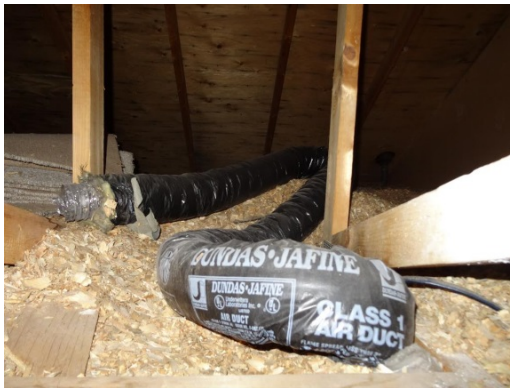
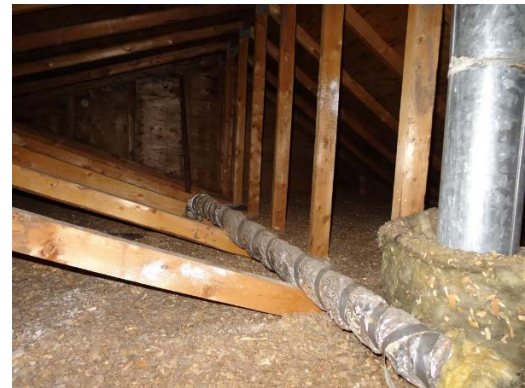
- Corrosion was observed at the seams of a number of the flues (Photo 24). Details regarding the frequency in which these flues are inspected is not known; however, further review is recommended at this time to assess the condition of all flues.
- Ductwork has become detached from the exhaust vent and is directing warm moist air into the attic space. This condition has resulted in a buildup of humidified air within the affected attic spaces and stains to the wood-framing members. Stain marked wood shaving opposite a bathroom exhaust vent were also observed during our initial site review (Photos 25 to 29).

Photos 26 and 27: Bathroom exhaust vent and plumbing stack in attic space

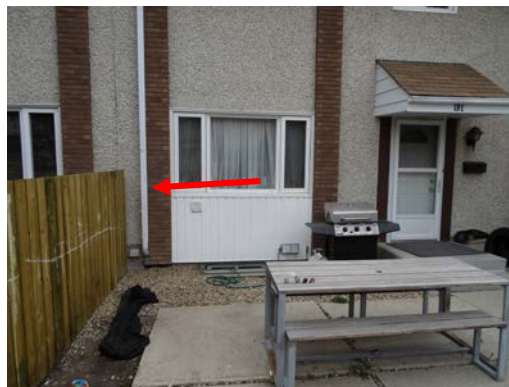
- Rooftop moisture is also directed internally via downspout extensions or plastic piping routed into lower levels of select units and at Building Blocks 3, 6, and 9 (Photos 37 to 39).

Photo 37: Downspout extension into lower level of suite

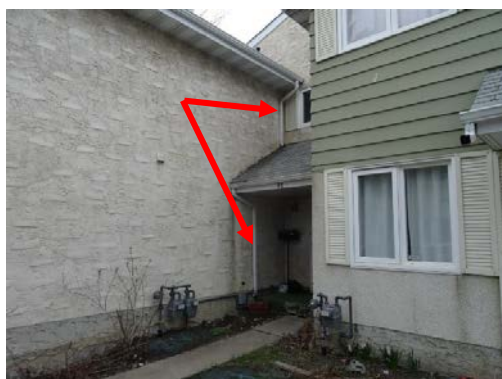
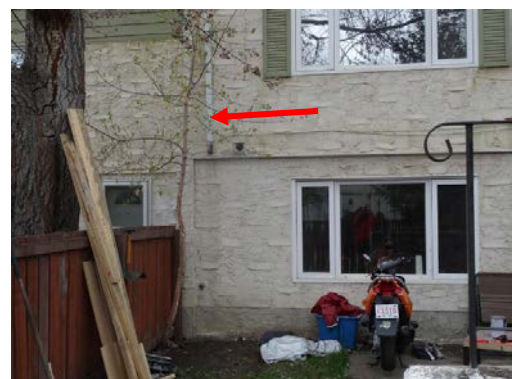
Photos 38 and 39: Downspout extensions routed internally at Building Block 9

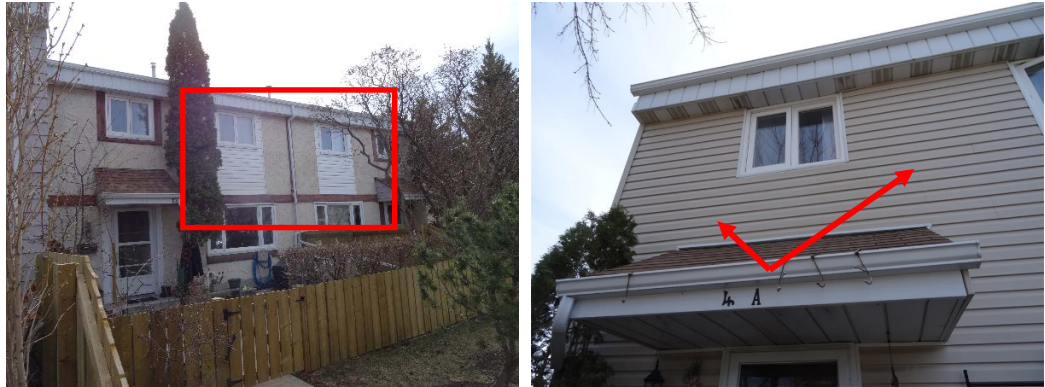
- We understand that select replacement of stucco and metal siding have been conducted in the past. The cladding replacements were reportedly required at that time to address moisture related ingress at the suites (Photos 51 to 53).

Photos 51 and 52: Vinyl siding at Units 2B, 2D, and Unit 4A where stucco replaced

- Although the extent or costs associated with the replacements are unknown, we understand that wood rot conditions are typically uncovered during the re-cladding repairs.

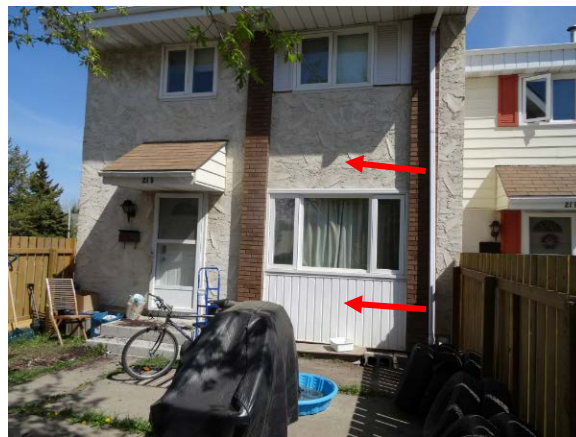
Photo 53: Original stucco and newer vinyl siding above at Unit 21D

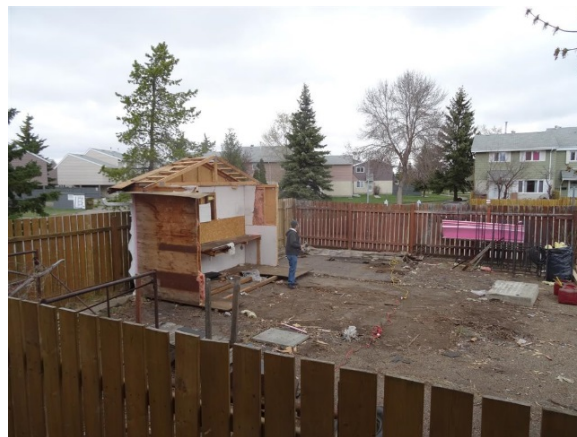
- Selected trim board repairs are anticipated under operating budgets until replacement is considered. Budgets related to eventual replacement of the wood trim boards are included in A2.06.
- The storage garage located on the west side of the complex was being demolished during a site visit (Photo 56). Specific details regarding the work were not available during our review. We were informed that the structure will not be rebuilt and that no budgets are to be included for replacement of the garage at this time.

Photo 56: Partially demolished storage garage on west side of complex

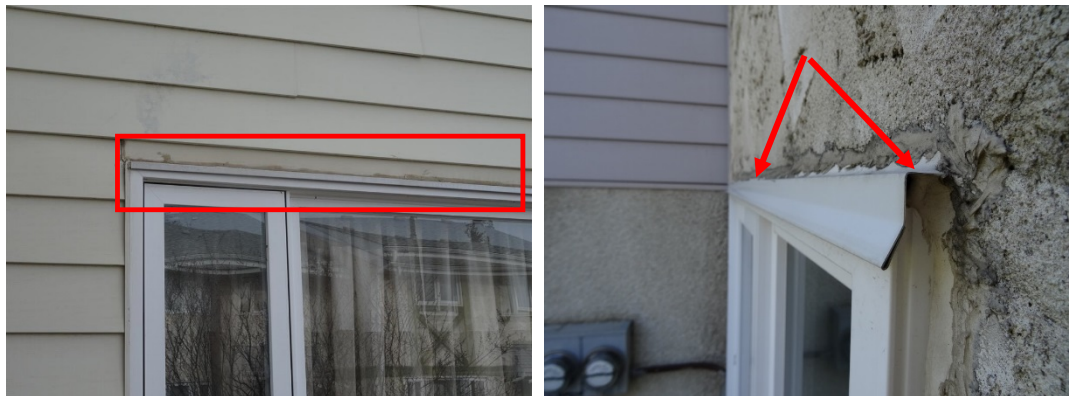
- The suite window at Unit 4A is protected by the upper roof overhang. The gap in the metal siding may allow rainwater to penetrate to the backup wall. Future review and selected removal-of the interior and exterior wall finishes to help determine the source of moisture ingress is suggested at both suites.
- Select windows include metal flashing inserted above and below the window units. This type of installation is likely attributed the method used by a particular window contractor retained in that given year of the program. We note the head flashings have been caulked at various suite windows (Photos 69 and 70).

Photos 69 and 70: Caulking bead applied to head flashing joint above suite windows

- We are uncertain if the caulking was included as part of the replacement programs or from past repair attempts. As a pathway for moisture to be directed to the outer wall cladding surfaces is required further removal of the applied caulking along the head flashing joints along with review of the windows at these locations is suggested.

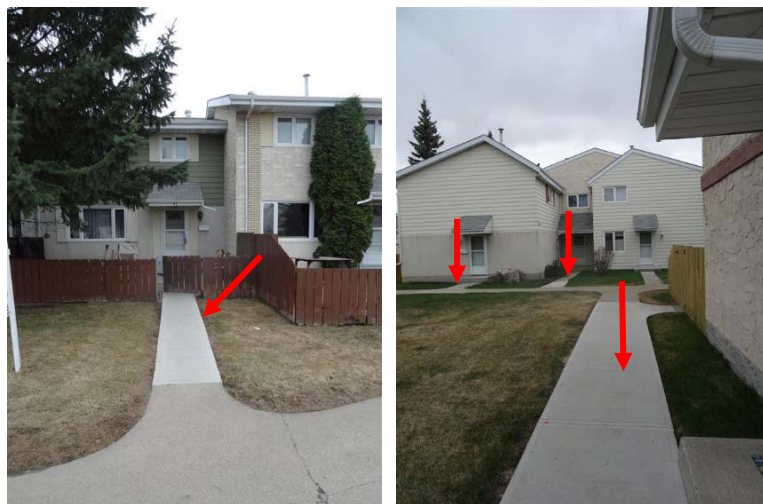
- Grading varied throughout the complex. Generally, the grading promotes drainage away from the building blocks. Nonetheless, future re-grading could include distribution of engineered fill and re-sloping grades to help promote drainage away from buildings. Sidewalks, entry steps, any Unit Owner improvements at the rear yards, and fencing sections will limit this work and consideration for these common elements should be given advance thought before proceeding with re-grading programs.
- A number of sidewalks sections have been replaced since original construction (Photos 76 and 77). Although details regarding the work were not available during our review, we noted the surrounding grades were not addressed as part for this work. Refer to budgets related to selected repair of the concrete elements under A3.01.

Photos 76 and 77: Newly installed concrete sidewalk pads at site

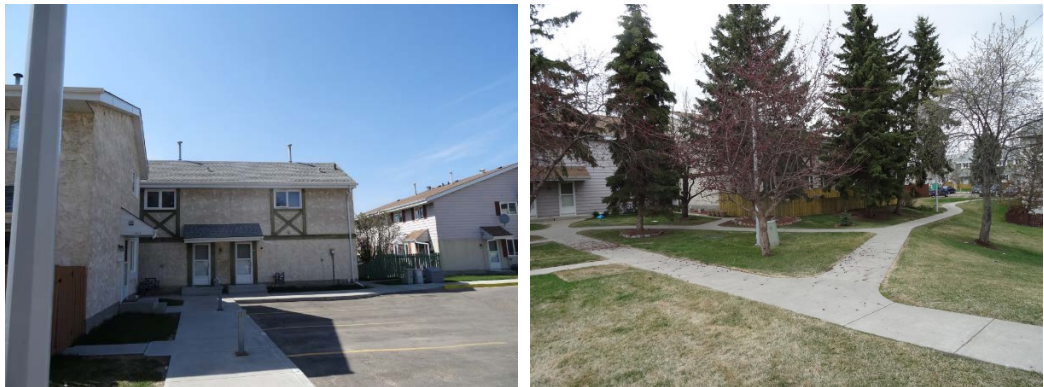
- Sidewalk pads lead from the parking areas to the front entrances and provide access between the north and south sides of the complex. The majority of these sidewalks are in good condition (Photos 79 and 80).

Photos 79 and 80: Sidewalks at parking area and pathway to north side of complex

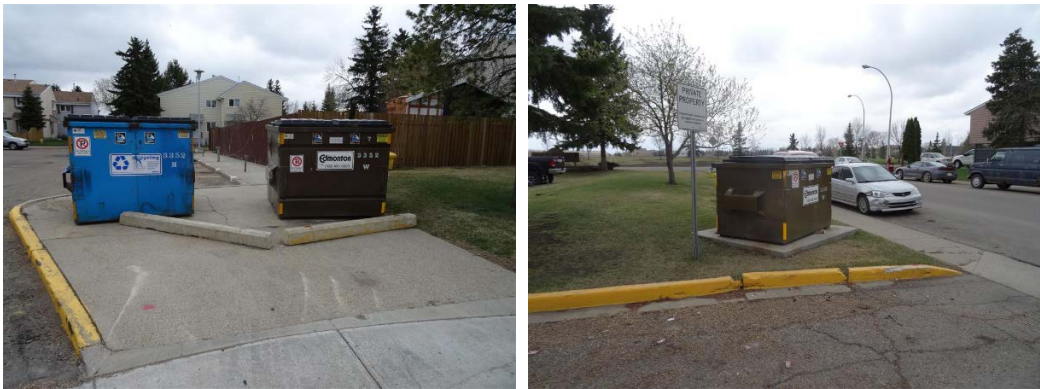
- Several sidewalk pads have been replaced. The date of installation and quantity varies around the site.
- Concrete pads are provided for refuse bins at various parking areas (Photos 82 and 83). Details regarding placement of reinforcement to accommodate the heavier load of a garbage truck are not known.

Photos 82 and 83: Concrete slabs for refuse bins on southwest and northwest side of site

Based on our initial review, we recommend retaining a geotechnical consultant investigate soil conditions on site. Inspection and testing of the soils would help establish recommendations for frost resistant construction of the concrete flat works (i.e. concrete sidewalks and patio slab on grades). This type of investigation should be reviewed in conjunction with grading.

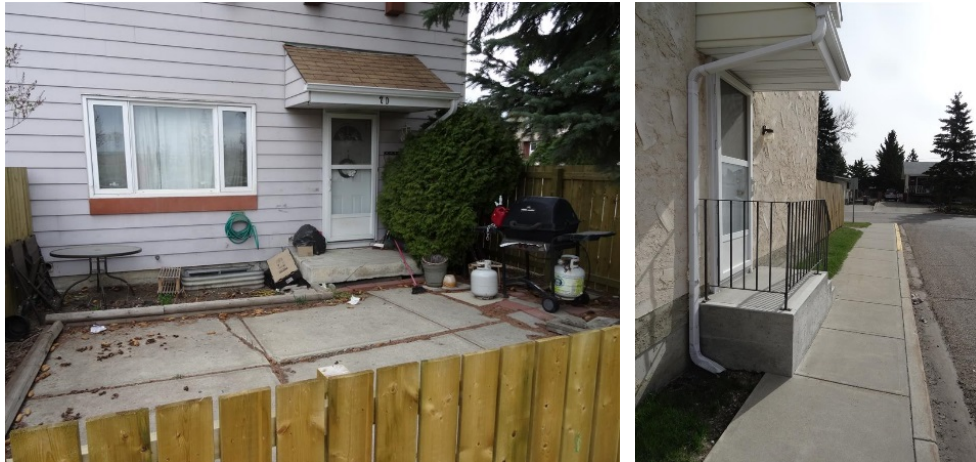
With the exception where some steps that have settled since original installation the precast steps are generally in good condition. We note the following observations:

- Several of the originally installed pre-cast steps have been replaced. The actual amount replaced, or the measures taken during re-installation, was not confirmed.
- Select unit entry steps and a retaining wall structure are supplied with wrought iron rails. Commentary and budgetary funding for re-coating operations and eventual replacement are included under Items A3.12 and A3.13.

Photos 84 and 85: Concrete stoop and 3-riser steps at unit entries

For the purpose of the reserve fund, we have included a budget for replacement of the concrete steps. In some cases precast steps may need to be pulled away from the building temporarily during re-grading work, concrete work, or the exterior restoration program to facilitate installation of new building papers, membranes, flashings, claddings, etc. This work would need to be reviewed in advance.

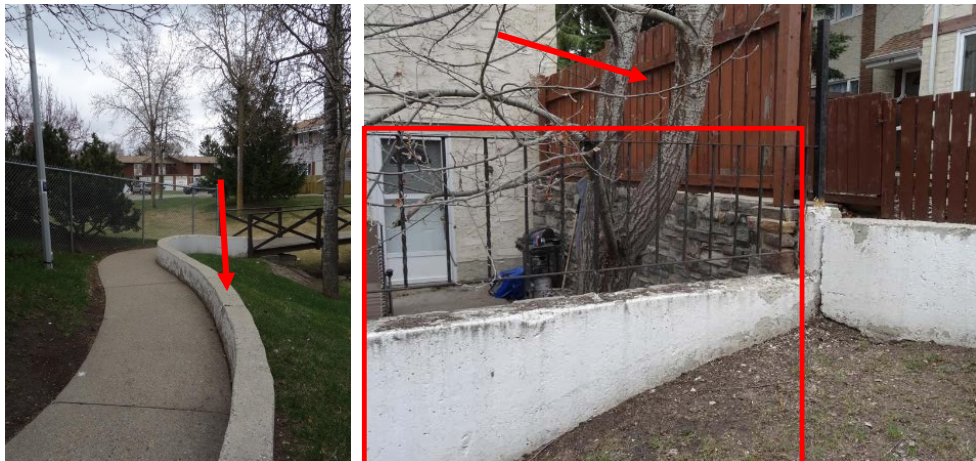
Photos 86 and 87: Concrete retaining wall and fencing sections

- With the exception of hairline surface cracks and peeling of the applied paint coating, the retaining wall is generally in good condition.
- The retaining wall is being relied on to accommodate grade differences at this location. Details regarding any drainage provisions along the wall are not known.

At the time of replacement, consideration should be given to increasing the drainage aspects of the grading adjacent to this wall area. Budgets include for replacement of the retaining wall. Structural review of these retaining walls is recommended to determine suitable construction details are included in the work at the time of replacement. Further investigation by a geotechnical consultant may be required to establish additional information about the soil conditions at this location.

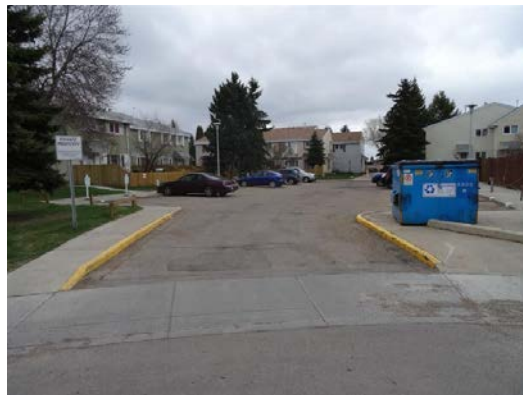
Photo 88: Asphalt pavement at southwest parking lot

- The majority of the asphalt pavement is in fair to poor condition, with cracking patterns and general degradation of the paved surface at various locations (Photos 91 to 94).

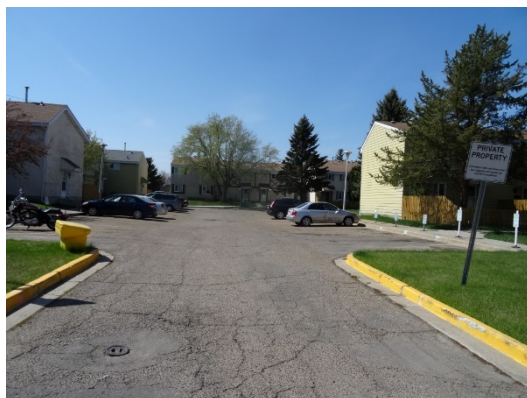
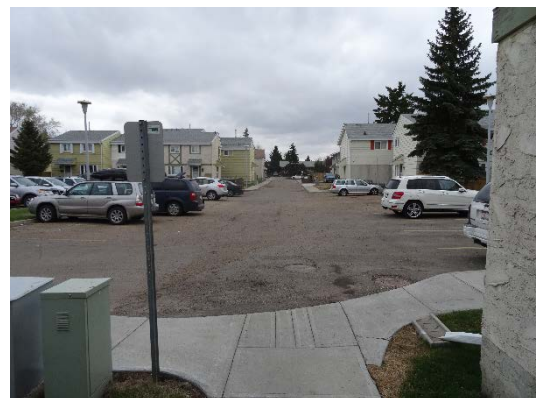
Photos 89 and 90: Asphalt pavement at southeast parking lot and drive aisle

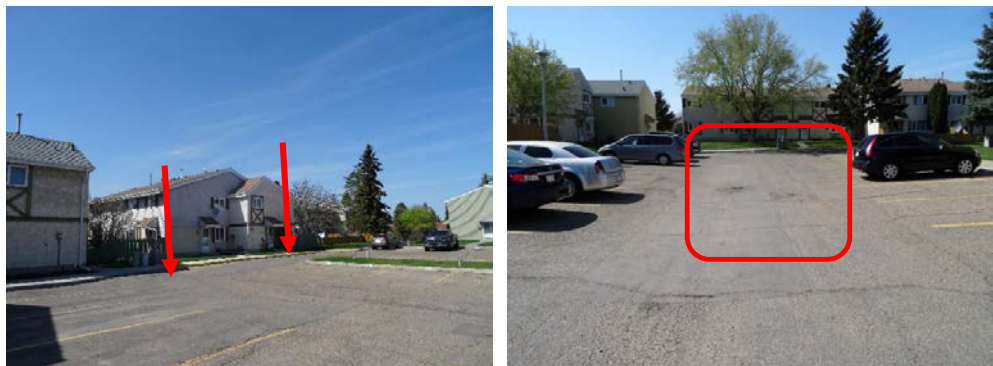
- Review of our prior study indicated that a phased replacement program of the originally installed asphalt pavement was to commence in 2007; however, the replacement program was postponed at that time due to other financial considerations at the site. No replacement work has been done since that time.
- We did note some patch repairs have been conducted in the past. The repair amount and location of these repairs varied from one parking lot to another (Photos 95 and 96).

Photos 95 and 96: Patch repairs to pavement at southeast and northeast parking lots

- Asphalt degradation and cracks are likely to continue over time from typical weathering and exposure of the asphalt pavement to vehicle traffic. We recommend fixing the cracks to minimize erosion of the soil based materials beneath the pavement and extend the expected life of the component until replacement is considered.

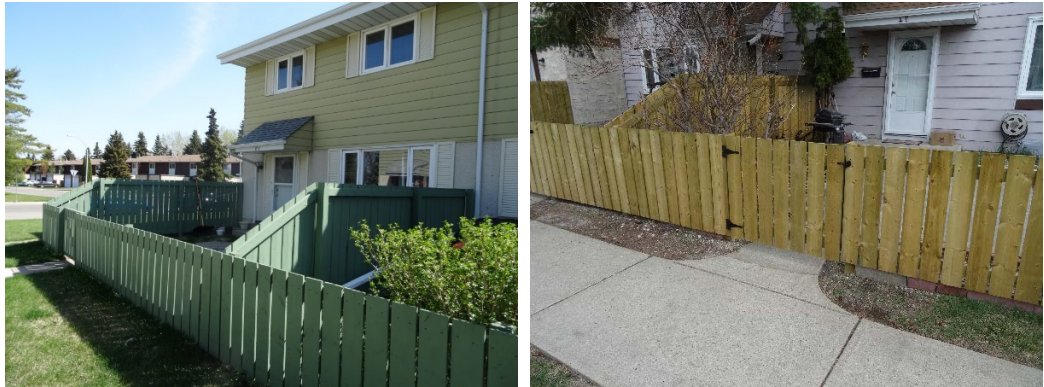
- In 2007, a fence replacement program was initiated at the complex. Since that time, additional wood fencing sections have been replaced. We further understand from correspondence received that the fencing project had been completed earlier this summer (Photos 97 to 100).

Photos 97 and 98: New wood fencing at front yard of building

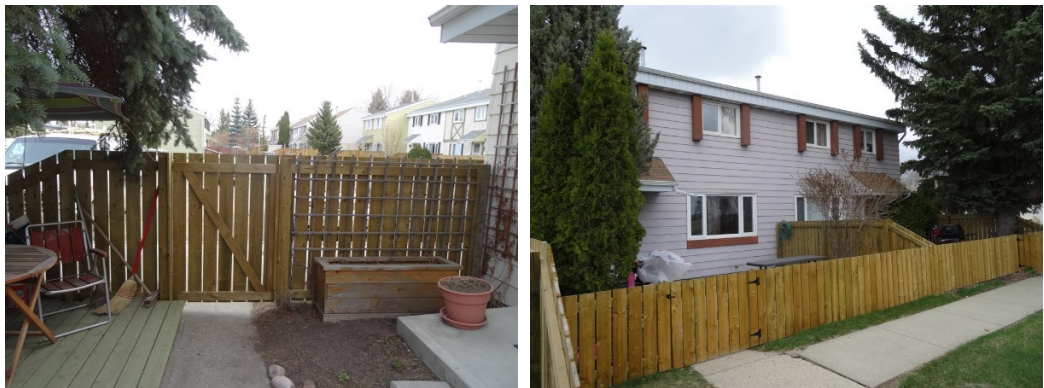
Photos 99 and 100: Privacy wood fencing at front yards

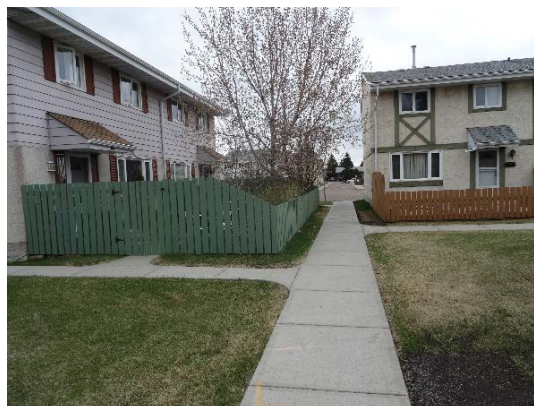
- The fencing program typically included installation in the first year, with the fence sections provided with a coat of exterior stain finish in the following year. Depending of the actual block building locations, the stain colour varies (Photo 101).

Photo 101: Green and cedar coloured stain finish applied to newer wood fencing

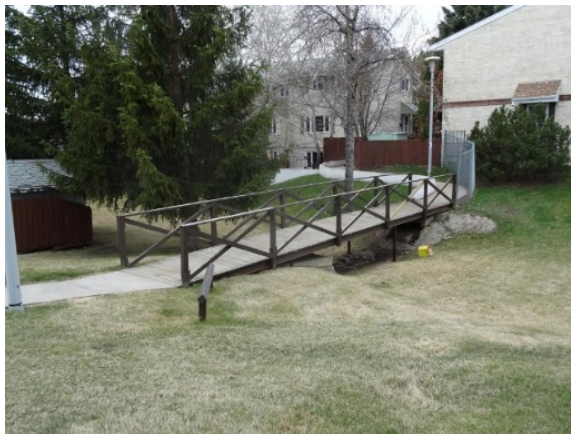
Photo 102: Bridge structure

- Review of 2009 reserve fund study indicated that the original bridge structure was restored in approximately 1999. Although bridge replacement was suggested in 2010, we note that this project was not completed.
- We understand from the Board that the guardrails were repaired in 2015 and that there are no plans for replacing the bridge structure at this time.

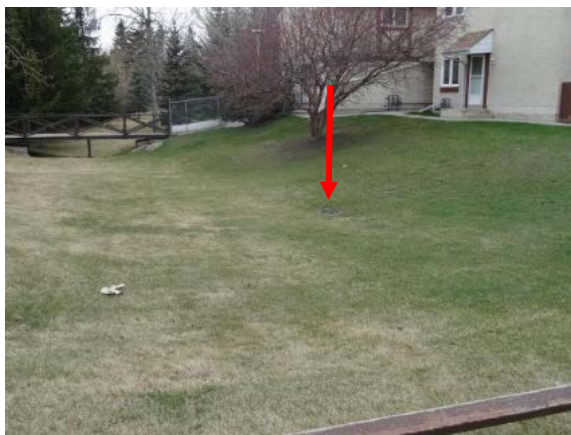
- A catch basin located on the east side of the landscaping swale is used to collect moisture (Photo 103). The condition of the piping sections are unknown at this time.

Photo 103: Catch basin situated on east side of landscaping swale

- As part of regular maintenance, it is recommended that the Board periodically examine the catch basins, manholes and associated piping to ensure leakage into the surrounding soils is not taking place. This could be performed using special camera equipment and contractors to complete this work. Continued visual inspections of the entire storm and sewer system will help prepare for future repairs or replacement that may be required. This type of inspection will help to establish conditions of the piping including deteriorated lines and/or sags in the systems. Findings could be used to prioritize any work that might be needed. Also regularly scheduled cleaning of the system is recommended as part of the maintenance program. We have not included these maintenance items in our budgets.

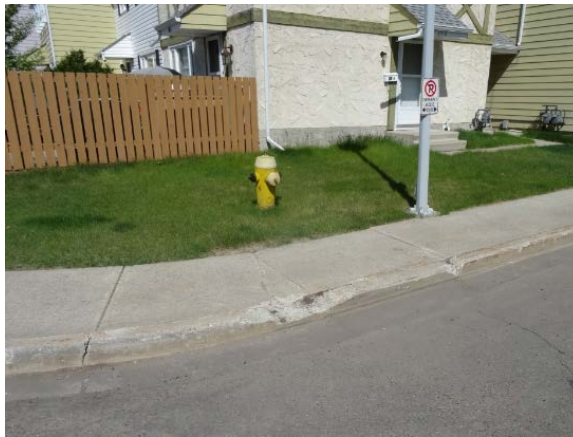
Photo 108: Fire hydrant on north side of complex

- As the complex is supplied with two fire hydrants, both hydrants should be considered for inspection to ensure that a constant supply of water is available at all times in the event of a fire condition.
- A lane provides access to a hydrant (Photo 109). To ensure emergency vehicles are provided clear access the laneway must remain clear and unobstructed at all times.

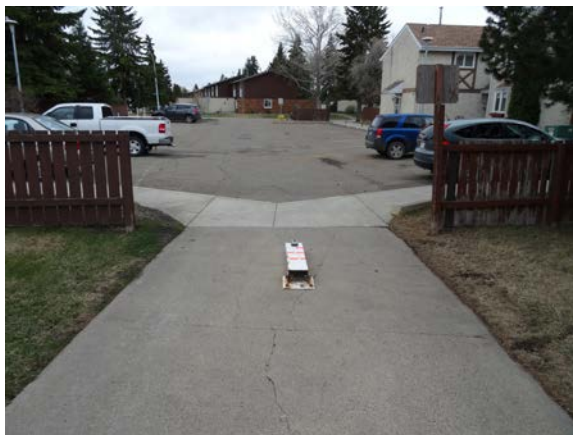
Photo 109: Guard at fire access laneway

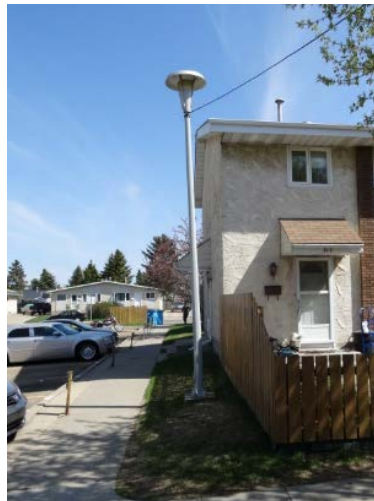
Pole mounted lights are located along the parking areas at the complex (Photo 110). In general, the light standards on the property looked to be in good condition. Replacement of the lighting will be required as part of the ongoing maintenance.

Photo 110: Typical pole mounted light standard at complex

Budgets have been included for complete replacement of the light standards throughout the complex.

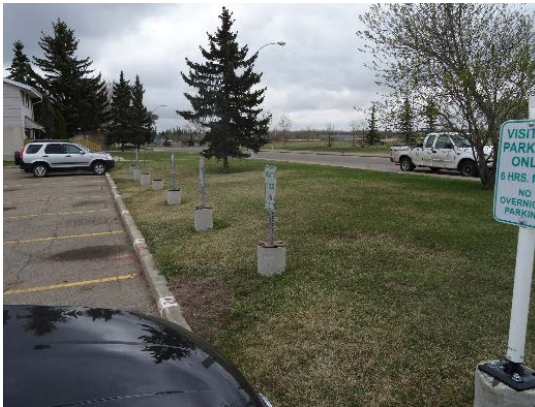
- Originally installed and newer pedestals service the parking regions. Newer pedestals include a concrete pile for additional protection and to raise the signs to meet local bylaws (Photo 111).
- Past removal of a pedestal at a parking stall located at the northwest parking lot was also noted (Photo 112). The reason(s) for the replacement are unknown at this time.

Photo 111: Newer concrete pedestals at south parking area of complex

Monitoring the parking receptacles combined with repairs as required should be anticipated. A budget for selective repairs of the receptacles has been included in the calculations.

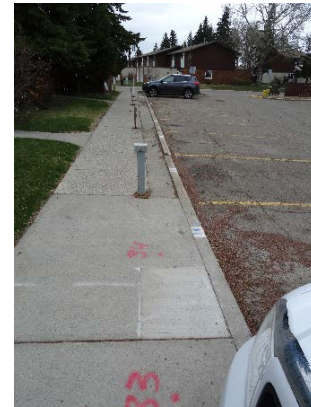
Photo 112: Newer concrete repair where pedestal located at northwest parking lot
